SAGGING TRUSSES - MYTHS UNCOVERED

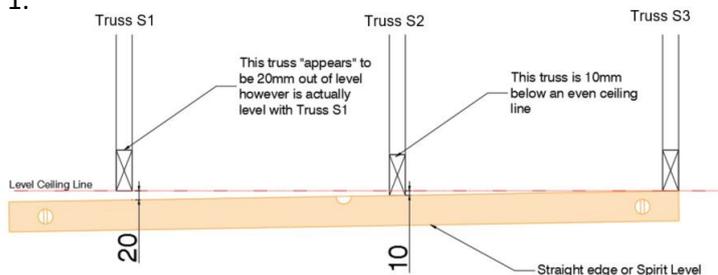
Fig. 1 - Inaccurate measurements with a straight edge or spirit level

Although S1 and S3 are at the SAME level when a straight edge is run over the three trusses, the S2 truss (which is down 10mm) causes the straight edge to project downwards and make it appear that it has deflected by 20mm!

Truss deflection can be measured as simply as a string line, however it is not as accurate or reliable as a laser level or an electronic water level. The level readings should be taken along the trusses span length, at each panel point location on the bottom chord (BC). This will give a true indication of how much the truss has actually deflected, as

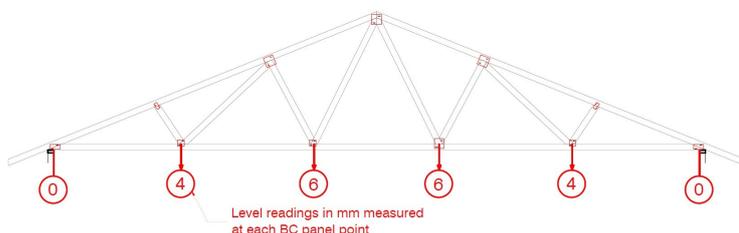
Fig. 2 - Truss measured at each BC panel point and readings recorded with a laser or electronic water level.

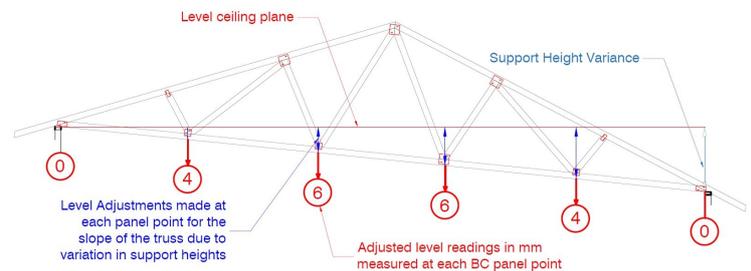
Level readings may also need to be adjusted to determine the ‘true’ truss deflection due to the fact that truss support heights may vary!

Fig. 3 - Level readings adjusted for uneven support heights

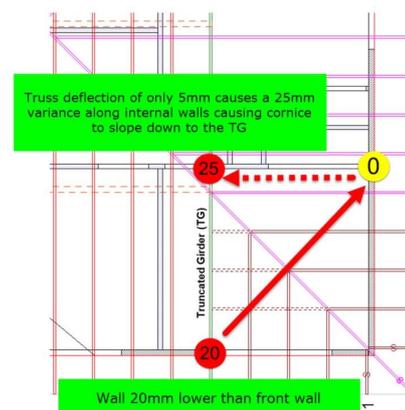
Variations in wall support heights can cause issues with clearance over internal walls – making it appear that trusses have excessively deflected. One example of this is a situation when there is a sloping cornice lines from an external wall to a Truncated Girder (TG).

It may appear as though the TG has excessively deflected, however level readings can often show that the front and side support walls are at different heights. In this example, the side wall supporting the TG is 20mm lower than the front wall supporting the jacks.

Fig. 4
Height variations of supporting walls

This issue, highlighted in Fig 4 and Fig 5, can be circumvented by spot level checks prior to installing trusses.

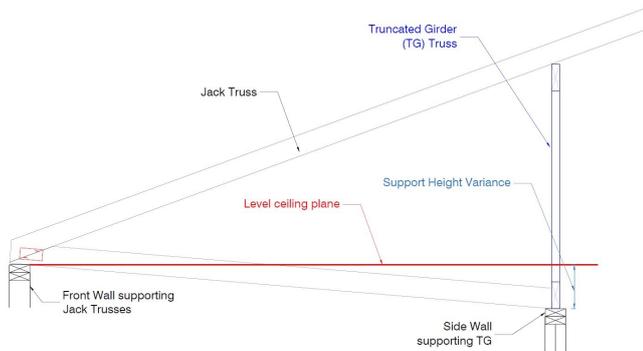
Fig. 5 - Uneven wall supports on jack to Girder connections as seen from a side elevation

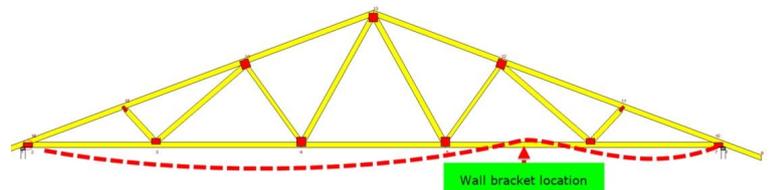
If nails are overdriven or fixed at the bottom of slots, the associated truss will not be able to deflect, while the trusses either side will. This can create an uneven ceiling line over the run of trusses. In addition, if the bracket is fixed mid-panel on a truss bottom chord, it can bow the bottom chord of the truss between the panel points.

Since the adjacent trusses are allowed to deform normally, the differential movement can cause cornice cracking. Refer Fig 7.

Fig. 7 - The deflected shape of truss can be altered by incorrect installation of wall bracket

In all cases it is advised to fix nails at the centre to top of slots and also not over-drive the nails.

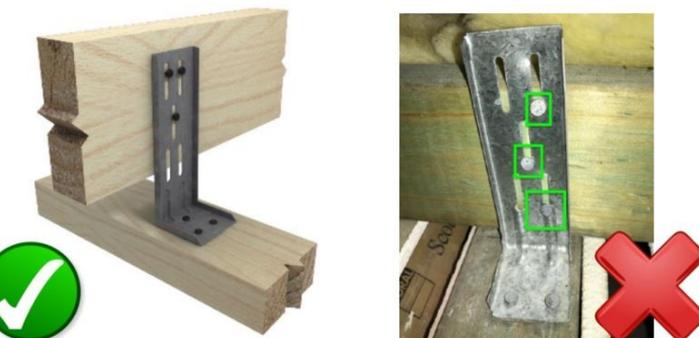
Internal wall brackets are designed to support walls laterally while the slots allow the trusses to deflect as dead loads are added to the trusses. They do this by letting the trusses slide down through the slots. Refer Fig 6.

Fig. 6 - Nails should not be overdriven or fixed at the bottom slots
